Home Inspection Report

STRAIGHT STREET

Property Address:

5260 16th Avenue NE
Seattle, WA 98105

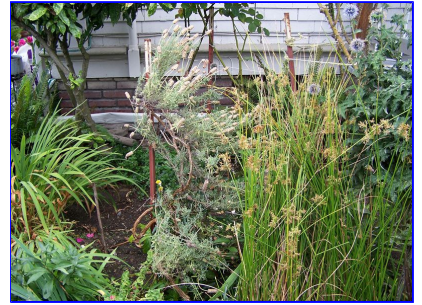
Trees & Shrubs

Condition: Satisfactory

All plants and trees very well manicured, no wood to earth contact or any conducive situations observed.

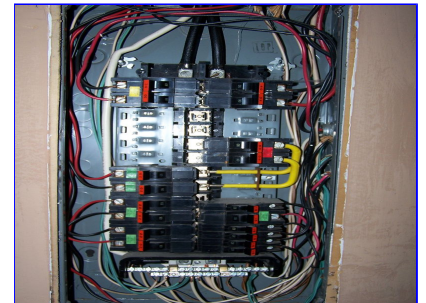
Service Line Entrance

Condition: Satisfactory
Type: Underground
Conductor: Aluminum
Location: Basement
Wiring: Romex (Encased in Plastic), Conductors in Conduit
Volts: 240 - 120v
Capacity: 200a

Dwelling has been re-wired within twenty years

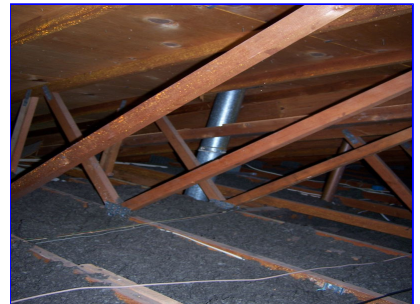
Attic Insulation

Condition: Satisfactory

Type: Batts, Combination, Cellulose

Average Depth (Inches): 12"

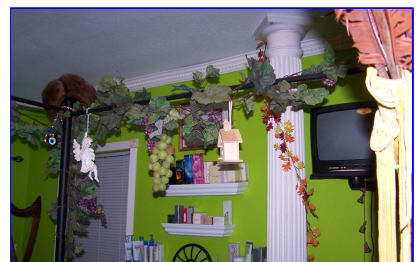
General Information

Master Bedroom with column and ornamental molding
